ANDROSCOGGIN RIVER BASIN
MOUNT VERNON , MAINE

FLYING POND DAM ME-00299

PHASE I INSPECTION REPORT NATIONAL DAM INSPECTION PROGRAM

APRIL 1979

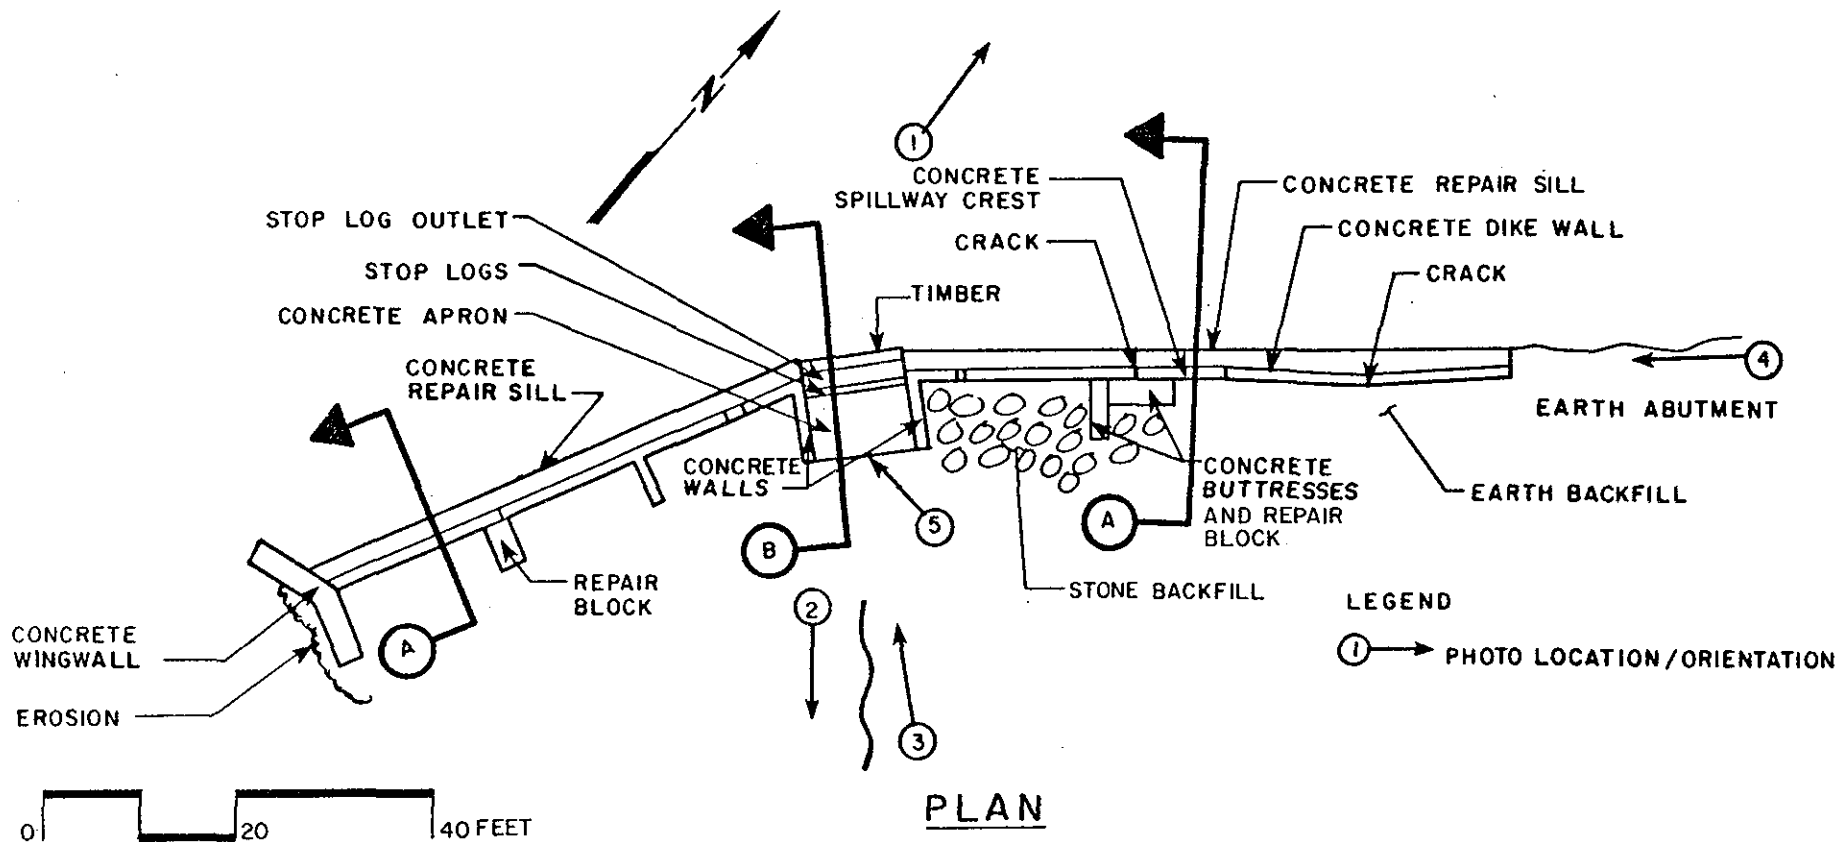
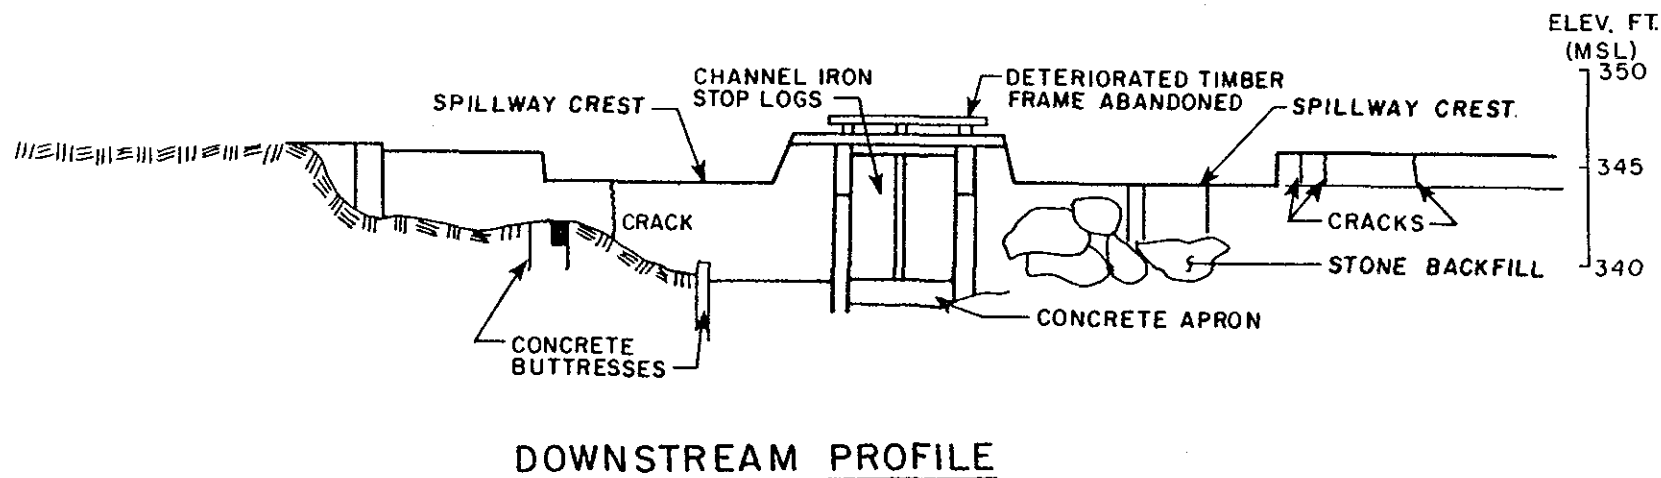
EDWARD C. JOHNSON CO. INC.	
PORTLAND, MAINE	
U.S. ARMY ENGINEER DISTRICT OFFICE	
CORPS OF ENGINEERS	
NATIONAL PROGRAM OF INSPECTION OF NON-FED DAMS	
FLYING POND DAM	
PLAN & PROFILE	
SCALE AS SHOWN	
DATE APRIL 1979	
M.E.

- (d) Repairs to the spillway and dike walls have been made in two areas in the form of support blocks placed upstream and downstream of the old walls (see Sketch in Appendix B).

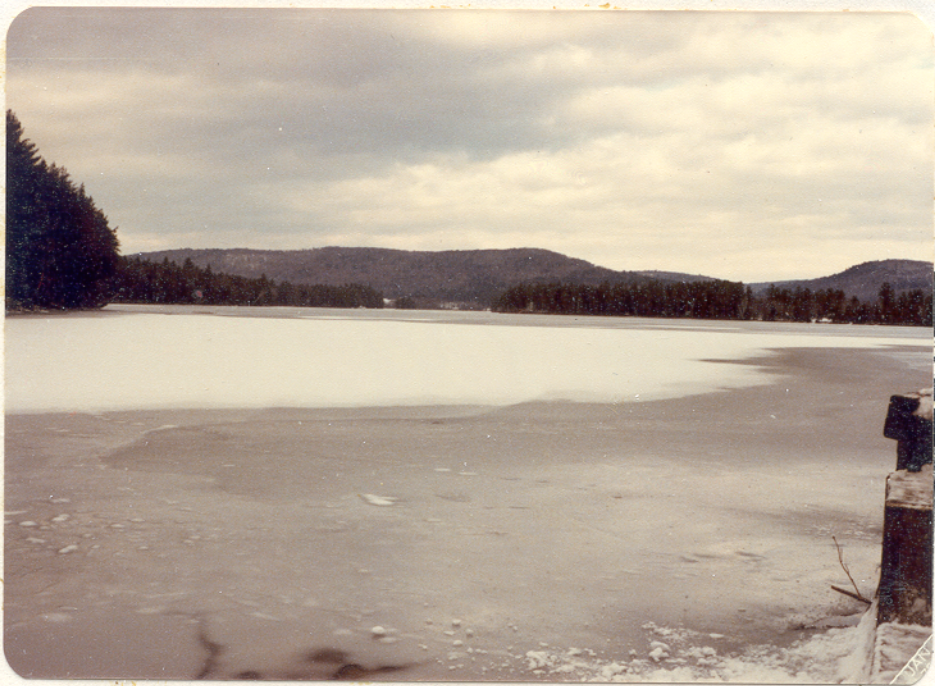
1
VIEW UPSTREAM

Upstream Channel - Flying Pond comprises the approach channel to the spillway (see photo No. 1). This channel is generally clear and unobstructed. The inlet area to the stop log bays is partially clogged with sand bags placed to reduce leakage.

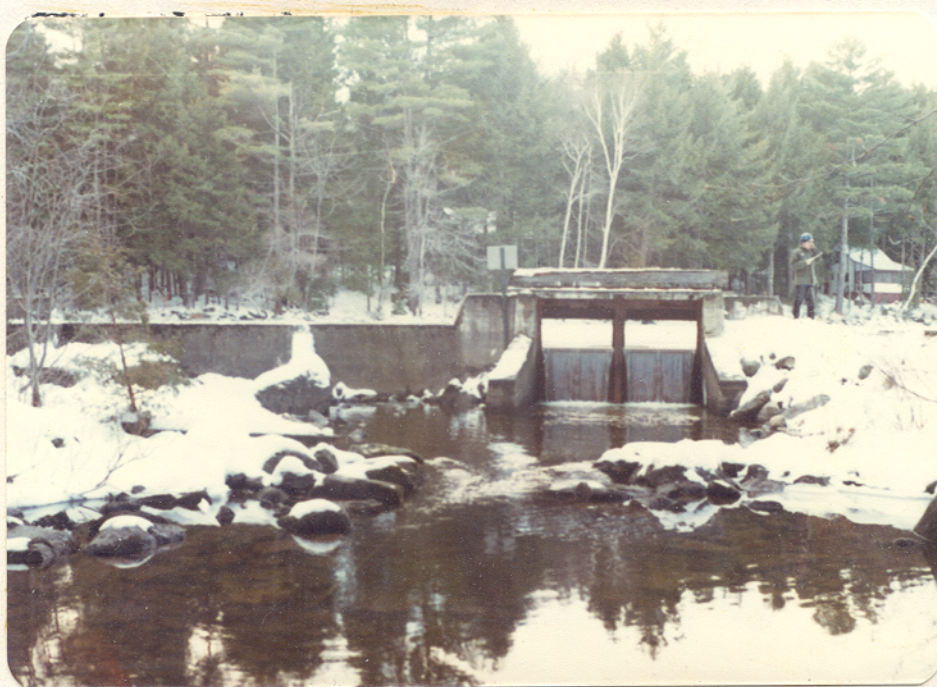
3
DOWNSTREAM FACE

The surface of the spillway and the surfaces of the controlled outlet were found to be in good condition with no evidence of erosion, spalling, or leakage (see photos no. 3 and 4).

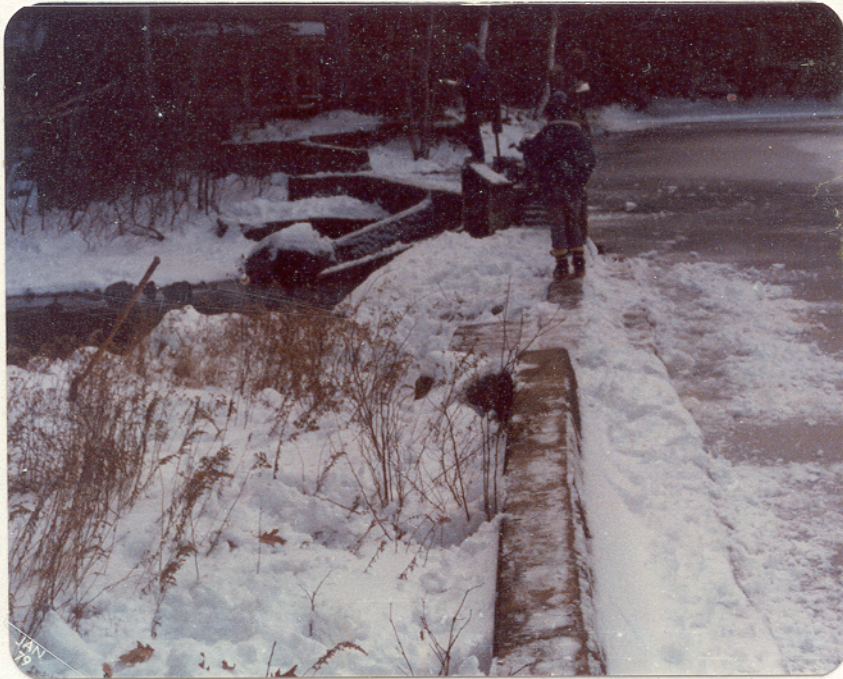
5
VIEW FROM NORTH ABUTMENT

- (a) The concrete dam structure appears generally true to line and grade. The east wing wall has deflected about 2 inches downstream (see photo #5).
 - (b) The concrete surfaces of the structure are in generally good condition, with little or no spalling or erosion, and only four narrow cracks are evident.

The westerly portion of the dam including the westerly wingwall, spillway, and dike wall and the easterly spillway wall, were all found to be true to line and grade. However, the easterly dike wall of the dam shows evidence of lateral movement in the downstream direction (see photo no. 5). The movement appears to be related to the structural cracking apparently due to overloading, perhaps by ice. The movement is approximately two to three inches.
